## **TECHNICAL REPORT TR-2361-ENV Revision 1**

### **ESTCP COST AND PERFORMANCE REPORT: RC-200610 Application of a Bimetallic Treatment System (BTS) for PCB Removal from Older Structures on DoD Facilities**

## **COST AND PERFORMANCE REPORT FOR: Application of a Bimetallic Treatment System (BTS) for PCB Removal from Older Structures on DOD Facilities**

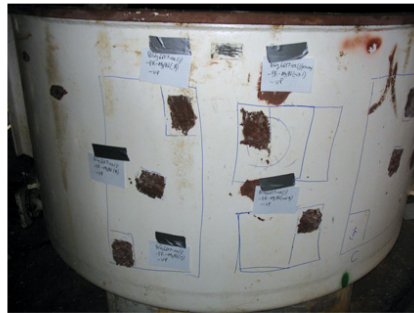
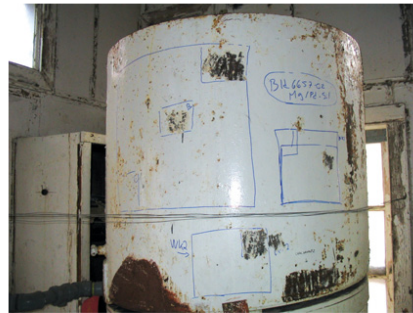
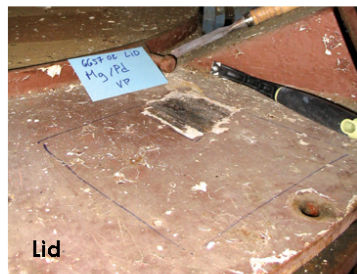
**Figure**  
**5.3**

**Large Tank**  
Mg/PD and NM-VP

**Small Tank**  
Mg/Pd Sil

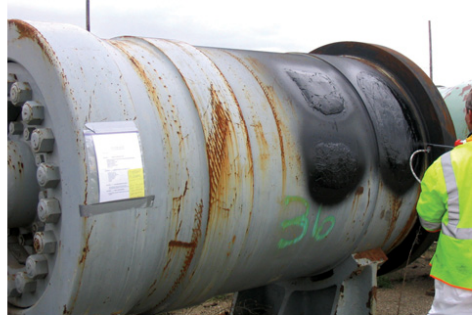
**Figure 5.4**

**BTS Paste applied to various spots on press #4, 12, 14, 15, 36**
